Memorandum

Subject: TETAP On-Call Services for Lafayette P04047.05

TETAP On-Call Services for Lafayette

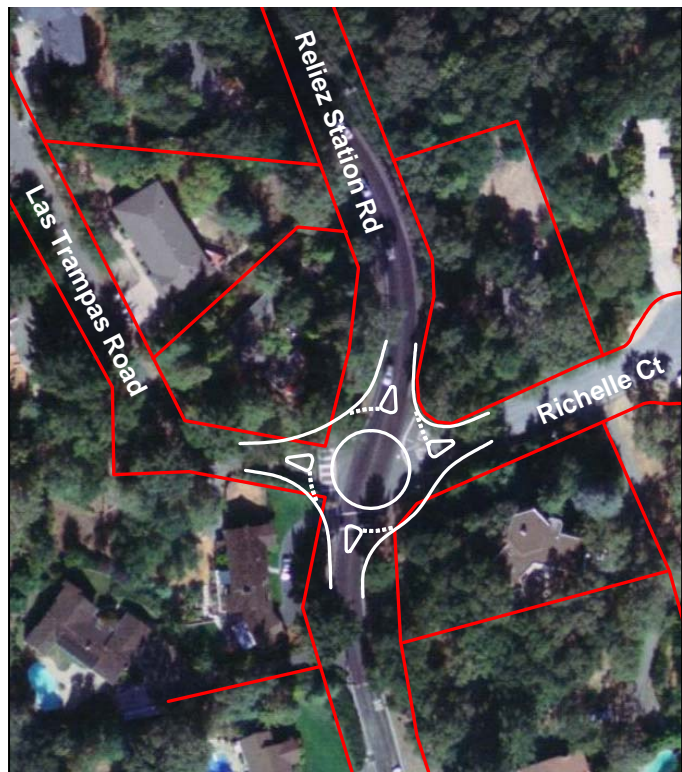
Figure 2: Potential Modern Roundabout

A modern roundabout could be a potential remedy at the intersection; however additional study would be required before implementing this option. An example of how a modern roundabout might be installed is illustrated in Figure 2. To accommodate the relatively high traffic volumes at the intersection, a roundabout design would need to have an inscribed diameter of 80 to 100 feet. The inscribed diameter is the distance across the roundabout to the outside of the traveled way. Although the figure does not show the roundabout to scale, it illustrates the likelihood that property would need to be acquired for the installation of a roundabout at this location.

Other issues should be considered before a decision is made to install a roundabout at this intersection. Installation of a roundabout may not improve safety at the intersection. Motorists traveling on Reliez Station Road would be required to yield the right-of-way to vehicles already in the circle. Vehicles stopped at the roundabout could be subject to rear-end collisions because of the limited sight distance on Reliez Station Road. In addition, because the number of conflicting circulating vehicles in the roundabout is likely to be low, motorists on Reliez Station Road may become complacent, may not expect the occasional conflicting vehicle within the circle, and may not yield as required before entering the roundabout. Finally, safety for bicyclists and pedestrians may not be improved by installation of a roundabout.

Before a roundabout is considered at this location, additional safety studies should be conducted. A roundabout should not be installed unless there is a demonstrated safety

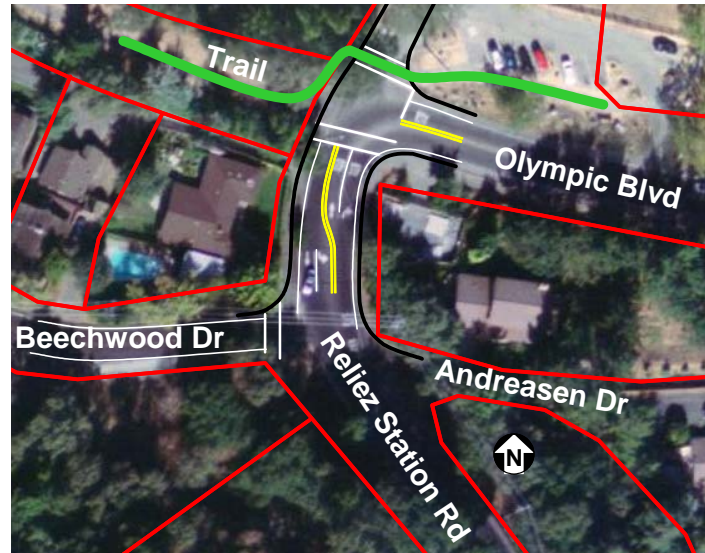
Figure 3: Reliez Station Road / Olympic Boulevard Intersection

Traffic congestion is a significant issue at the intersection of Reliez Station Road and Olympic Boulevard during the peak traffic periods. The intersection is controlled with stop signs for all approaches (Figure 3). Traffic queues build on northbound Reliez Station Road during the morning peak hour and westbound along Olympic Boulevard during the afternoon peak hour. Rear-end collisions for northbound traffic on Reliez Station Road has been identified by City staff as a safety problem.

Two options were developed to alleviate congestion at the intersection. Any alternative that would significantly reduce congestion would have to reduce delay for northbound right-turning traffic on Reliez Station Road and for westbound left-turning traffic on Olympic Boulevard.

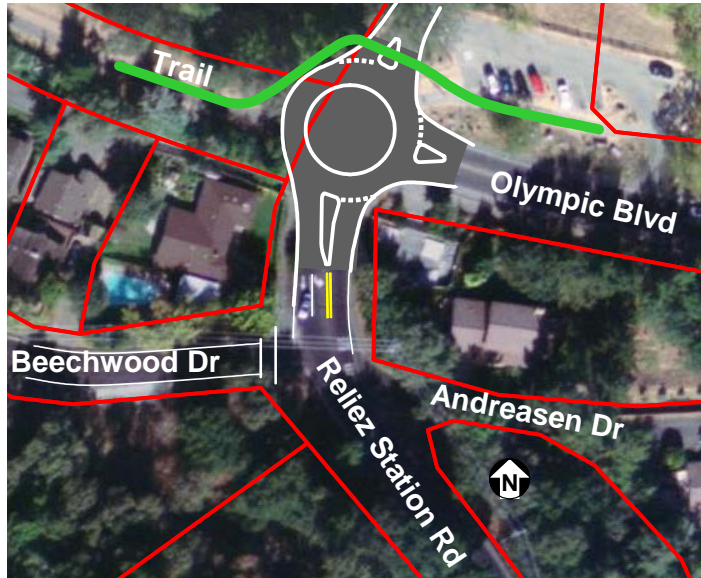
Figure 4: Roundabout Alternative

Another alternative for reducing congestion at the intersection involves the installation of a modern roundabout (Figure 4). Many of the same issues discussed for the application of a roundabout at the intersection of Reliez Station Road and Las Trampas Road would also apply to the intersection of Reliez Station Road and Olympic Boulevard. The roundabout would need to be relatively large to provide adequate capacity and would require the acquisition of nearby property.

A roundabout may not improve traffic safety because of the low volume of traffic using Reliez Station Road north of the intersection. Also, a roundabout would increase the traffic flow south of the intersection and make it more difficult for traffic to enter Reliez Station Road from Beechwood Drive and Andreasen Drive. Finally, crossing the north leg of a roundabout may be more problematic for users of the Lafayette-Moraga Regional Trail.

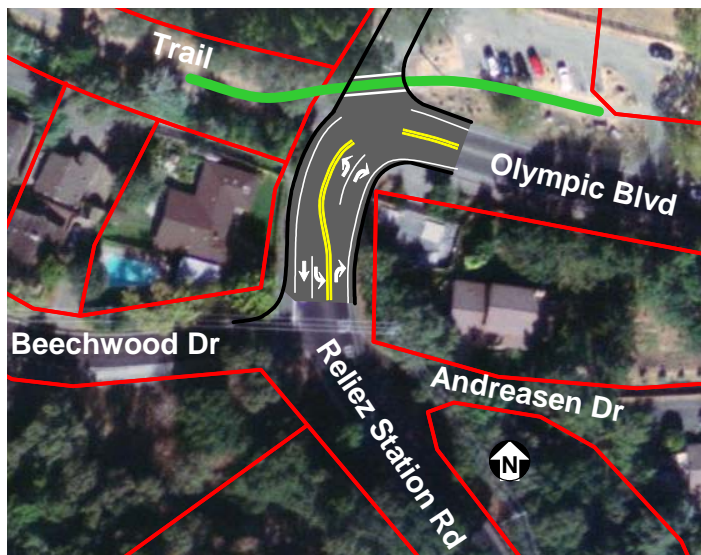
Figure 5: Side Street Stop Control

The last alternative considered for the Reliez Station Road / Olympic Boulevard intersection was a conversion of the traffic control to side-street stop control, only (Figure 5). This alternative would involve removal of stop controls for northbound Reliez Station Road and westbound Olympic Boulevard. Stop controls would be retained for southbound Reliez Station Road. The roadway may need to be widened to accommodate this change.

This alternative would reduce delays at the intersection for the heavily traveled route; however, there would

We do not recommend major changes to the traffic control at the Reliez Station Road / Olympic Boulevard intersection unless more extensive studies show that the changes would be warranted. It is our opinion that a traffic signal could improve traffic operations by maintaining smoother traffic flow for the predominant vehicular movement at the intersection; however, we caution that a traffic signal should not be installed unless one or more of the signal warrants are satisfied. We do not believe the installation of a modern roundabout at the Reliez Station Road / Olympic Boulevard intersection or converting the intersection to side-street stop control would be appropriate.
